## Ultrasonic Inspection of Titan IV Stage I Baffles

1 March 1996

J. P. NOKES  
Mechanics and Materials Technology Center  
Technology Operations

**THE AEROSPACE  
CORPORATION**  
El Segundo, California

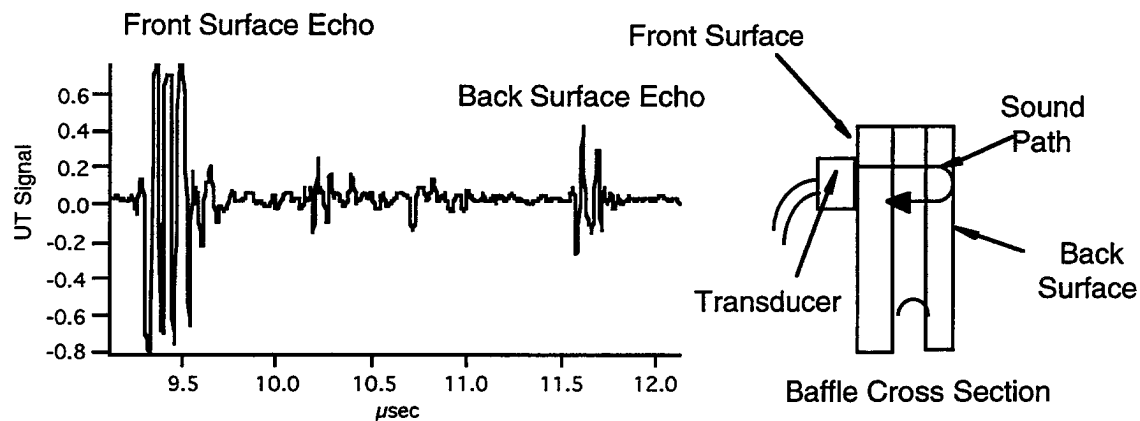
Figure 4. Ultrasonic signal from a baffle rib indicating a good contact between both face plates and the rib.

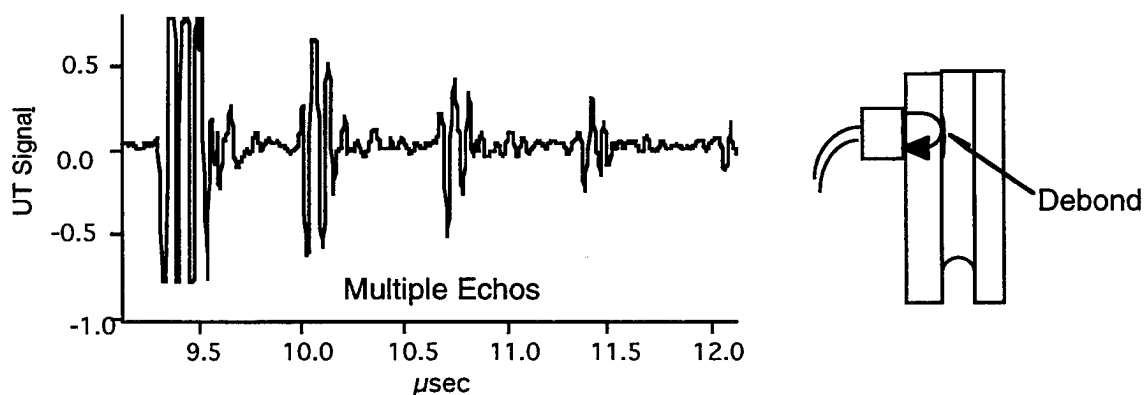
The signal displayed in Figure 5 is typical of the return that would be expected from a front-faceplate/baffle debond. In this case, the ultrasonic pulse travels a path that is equivalent to twice the thickness of the faceplate. As a result, the waveform in Figure 5 is also characteristic of the signal obtained from a position on the baffle between ribs since the normal faceplate/air interface is indistinguishable from that of the faceplate/baffle with a debond.

Figure 5. Ultrasonic signal showing the multiple reflections typical in the front surface debond.
